DEPARTMENT OF TRANSPORTATION

Contract #: 04-0120F4Cty: SF/ALA Rte: 80 PM: 13.2/13.9File #: 69.28**WELDING INSPECTION REPORT****Resident Engineer:** Pursell, Gary**Address:** 333 Burma Road**City:** Oakland, CA 94607**Report No:** WIR-009910**Date Inspected:** 28-Sep-2009**Project Name:** SAS Superstructure**OSM Arrival Time:** 700**Prime Contractor:** American Bridge/Fluor Enterprises, a JV**OSM Departure Time:** 1900**Contractor:** Zhenhua Port Machinery Company, Ltd (ZPMC), Changxing Island **Location:** Shanghai, China

WELDING INSPECTION REPORT

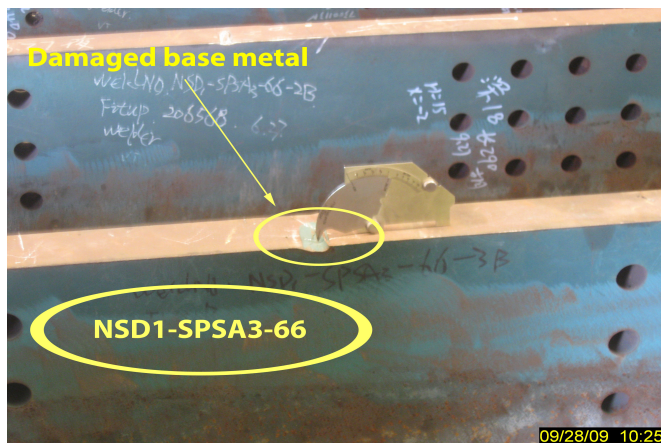
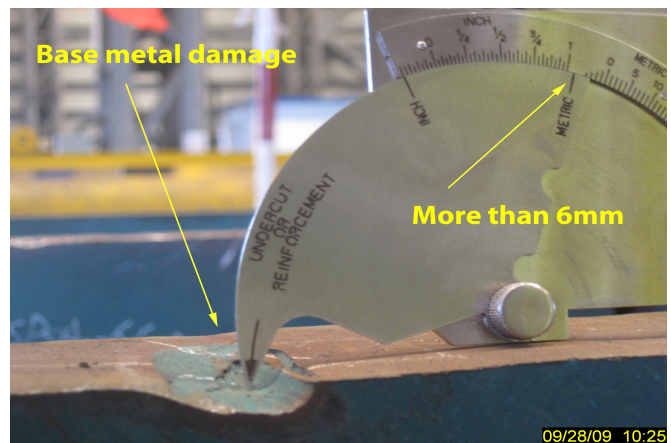
During random verification Visual Testing (VT) of stiffener of north tower interior splice plate, located in the Tower bay 10, Caltrans Quality Assurance (QA) Inspector observed stiffener base metal was damaged at the edge. The stiffener base metal damage was measured as being 50mm in length, 25mm in width and more than 6mm in depth approximately. This damage was caused by gas flame cutting and the stiffener was identified as NSD1-SPSA3-66. This QA inspector prepared an incident for this issue. The attached photographs provide additional detail.
